18-11-2014; 2 x Philips PRO-12 on e-market

28-11-2014; start of the restoration

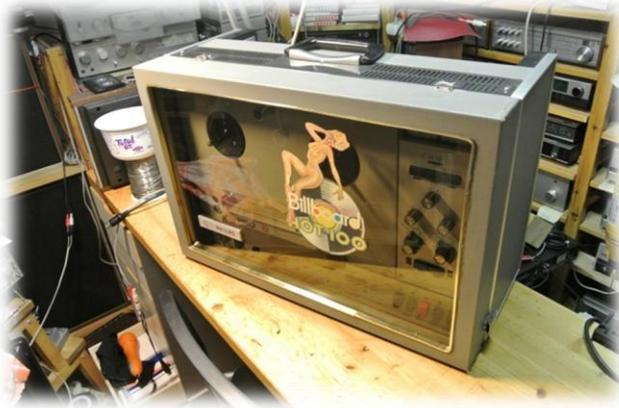
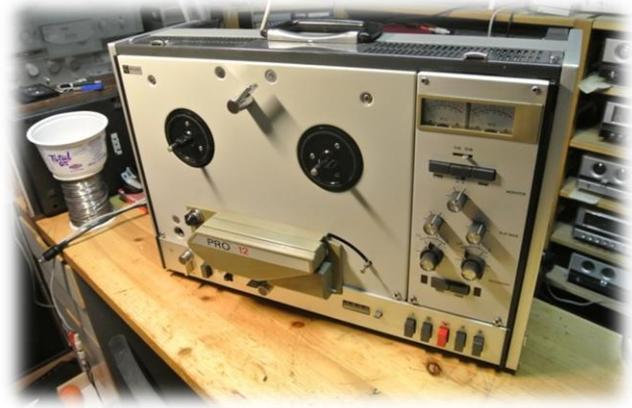
It has taken a while before I started with the PRO-12. I first had to service two Philips MFB544 speakers for a fellow enthusiast. But today is the big day. The first findings of the PRO-12: the recorder still looks neat, dusty though but clean, lettering is all present no missing pieces, everything seems to be original. Next I removed the cover plates: counter belt has dried up, heads still on factory settings, tape path and heads are very dirty there has been used tape of bad quality. The tape path reminds me of the ReVoX a77, using a circular guide roller with ball-bearing on the left and on the right side a rigid one. The construction of the tape guides are more solid than the often small tape guides on the Philips Consumer recorders.

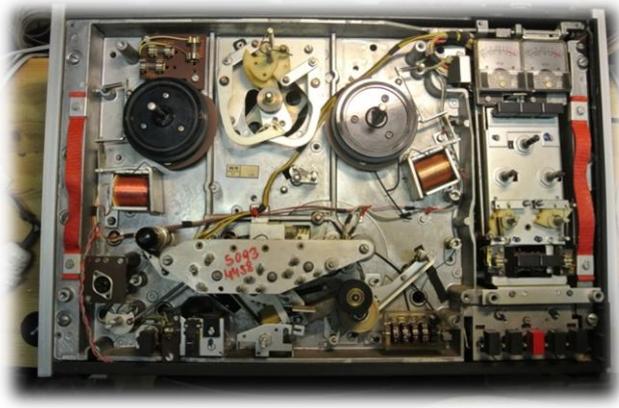
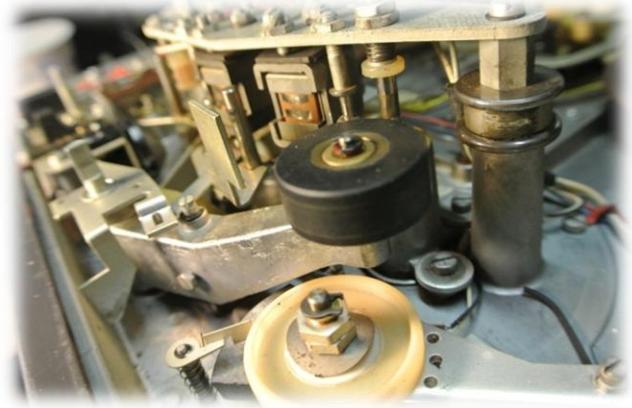
I now begin to understand why these "small" recorder weighs so heavily. A one-piece moulded aluminium frame, everything is just a bit heavier than the Philips Consumer recorders that I know. The frame has two handy straps at both sides of the frame to lift out of the recorder. The PCB's are all good accessible by a way of unfolding them and repairs can be made easily. It's is always pleasant to see that there has been thought about performing service work. Drive belt of the capstan has turned in to rubber sludge. Fortunately it is not throughout the whole recorder. The rest looks fairly clean at the inside.

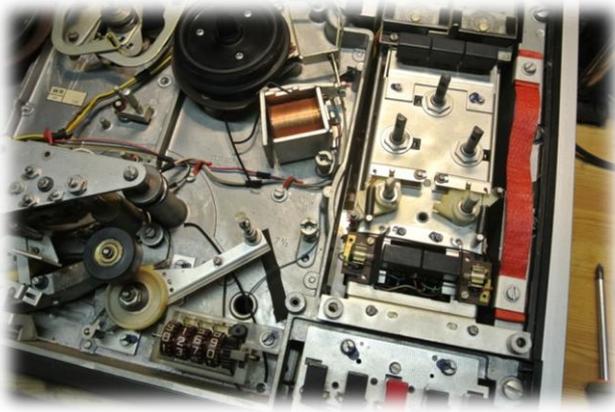
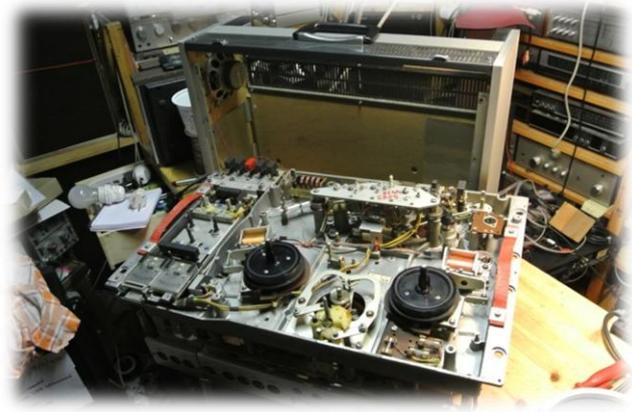
What also stands out are the winding motors, big alternating current types. I have never seen these in consumer recorders from Philips. They also ensure some extra weight. The capstan motor looks familiar and resembles the capstan motor of the Philips consumer recorders such as the N4407.

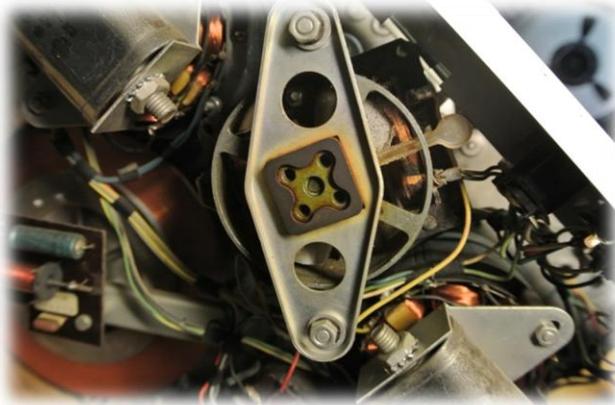
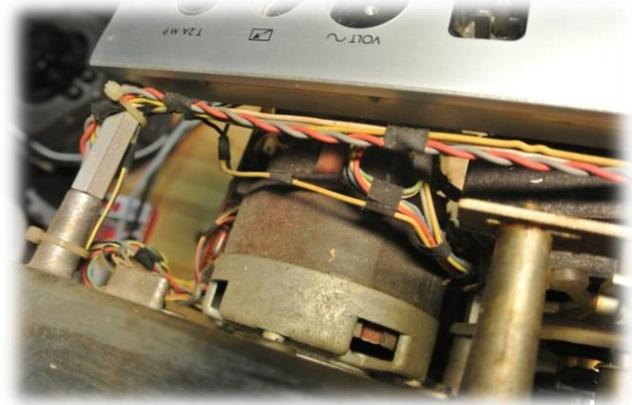
At the rear view immediately the remarkable large flywheel attracts the attention. The flywheel is provided with a kind of copper (coloured) disk which runs between two permanent magnets. These two magnets are mounted on a bracket which is connected to the speed control lever. The position of the bracket depends on the position of the speed control lever. Everything seems to be mechanical. No wires connected to electronics. I do not understand the exact function but I am sure I will find out later.

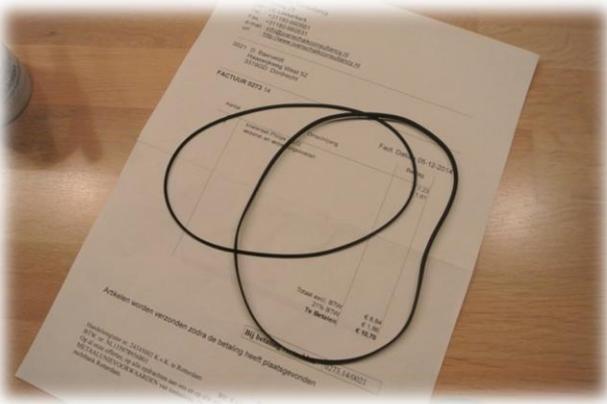
It took a while before the belts arrived but nevertheless I was pleased to have them. Now I can start installing them and check if the recorder is still working. The construction for the adjustment of the belt in order to change the speed is a piece of fine mechanical art to me. I have never seen this construction before in a tape recorder of any brand. When operating the speed control lever the drive belt is picked up by two little rolling guides on brackets. Next the belt is "folded" open and moved to the other pulley diameter on the capstan motor. All this happens in one movement caused by the speed control lever. The capstan motor turns always at just one speed. Speed of the capstan is adjusted by the different pulley diameters on de capstan motor.

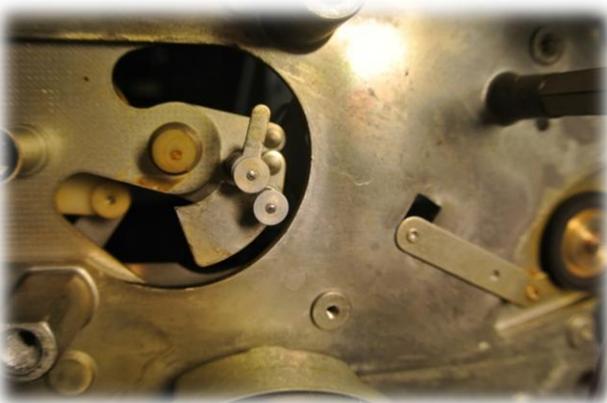
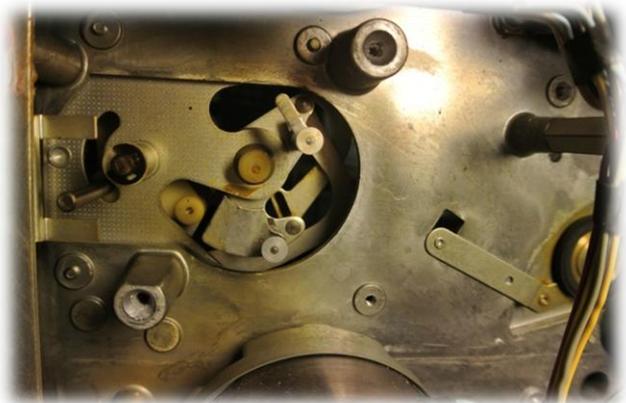
On the pictures you can see the two rolling guides in closed situation (left) and halfway (right)

First I have lubricated the capstan motor. Next I soldered the wires back to the capstan motor I always mark the wires and the connection to be sure the wires are on the right connection again. I Assembled the new belt on the motor pulley and mounted the capstan motor back on the frame. After the capstan motor was mounted I put the belt around the flywheel and applied the flywheel back in its bearing after lubricating the axis. Don't forget to apply the plastic ring on the axis of the capstan on the front side. Finally I replaced the bracket with the little nylon bearing behind the flywheel axis and the job has been done. Capstan motor and flywheel are rotating as new. I cleaned and greased the speed control mechanism and checked functioning. Al works fine and now we can check if the recorder is still working, this is always an exciting moment to me.

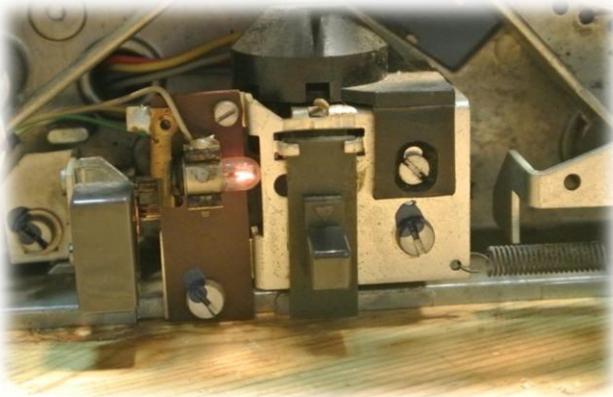
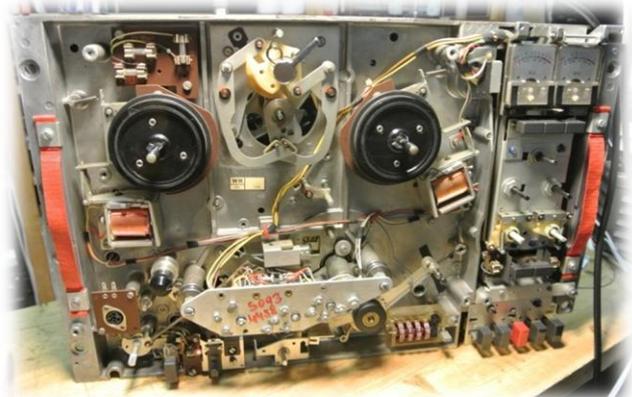
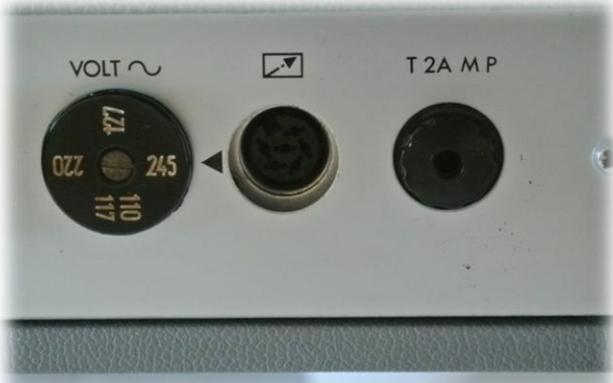
At first I changed the power carousel to 245(V). The average voltage of the contemporary electricity connections of our homes is about 230(V) nowadays. The setting of the power carousel on 220(V) is too low, it could damage the old electronic components.

A start up of an audio device which has been sleeping for so many years has to be done on a easy and controlled way just to wake up the electronic components again. For this purpose a variac (variable transformer) is used. A 220(V) light bulb is connected in series with the variac. When there is any short circuit the 220(V) light bulb will light up strongly. In that case power off and you will have to repair the cause of the short circuit first.

I Connected the PRO-12 to the variac with the 220(V) light bulb in series and increased the voltage until 80(V). The light bulb of the power ON switch lights up a little. The light bulb in series with the variac does not light up so there seems to be no short circuit. After about 10 minutes I increased the voltage to 120(V). The capstan motor starts rotating slowly. I Increased the voltage again after 10 minutes to 180(V). The light bulb in series with the variac is now starting to light up a little bit but it seems logical to me as a result the recorder now consumes the necessary power. After 10 minutes I increased the voltage to 220 (V). Capstan motor is running fine, electro magnets are functioning, no strange symptoms, everything seems to be fine. This PRO-12 is back alive after some 20 years retirement...!! I Removed the variac after 20 minutes and connected the recorder directly to the net. Next we will start testing the condition of the rest.

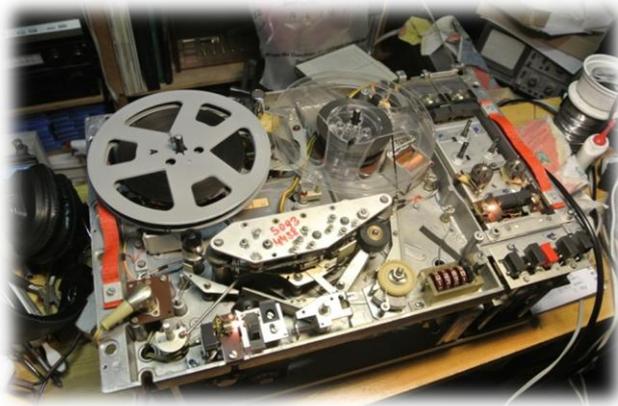
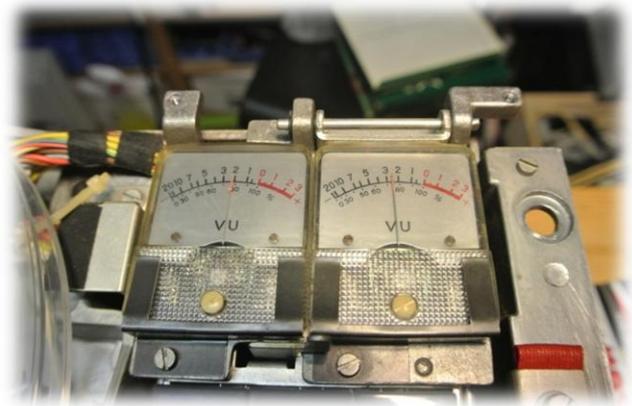
I put an old tape on the PRO-12, connected the monitor output to an Philips 22AH561 amplifier and activated the play button. Yes....., after 20 years of silence there was sound produced by the old PRO-12. Sometimes there are sound drop outs. After messing around with the switches and potentiometers the sound returns again, an IPA treatment is necessary. Winding clockwise and anti clockwise is also going well. Winding is going really fast and when the stop button is activated the reels almost stop immediately, I am impressed. Everything runs quite silently and smooth. The axis of the pinch roller arm needs to be lubricated but that seems to be the only problem. If that's all this becomes an easy restoration.

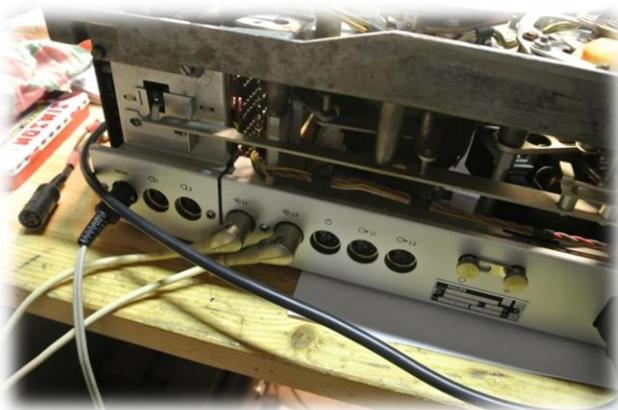
I Connected a CD-player to see if recording also still works. That took some time because the PRO-12 has separated DIN connectors for the left and right channel so I had to make some DIN / ¼" jack split cables. I had to consult the manual first to find out how all the knobs and switches had to be set because the PRO-12 has a lot of possibilities to create and play back recordings .You can set the recording level and play back level independently of each other. In this way you can control the input level of the source (Before tape control) and the recording level (After tape control). By using the VU-meters the set up can be controlled independently and set on an equal level.

I made some recordings from a CD of by Tiësto. The recordings, sounds good, Before as well as After-tape. It sounds, based on my hearing, quite well. I had the idea to do an elco-replacement right away but given the results I will first use the PRO-12 for a while and then decide for an elco replacement later. First I will perform the remaining work. The recorder works and sounds alright for me.

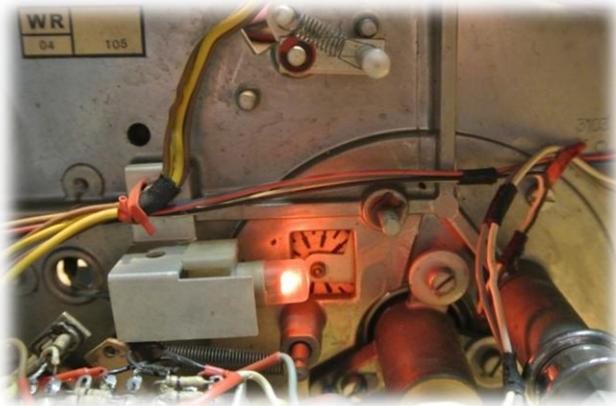
The speed of the PRO-12 can be set on the basis of a small built-in tacho disc. Above the tacho disc a light bulb has been mounted. This tacho disc can be pressed against the capstan with a lever. The tacho disc indicated that the speed was not entirely correct. The speed control is purely mechanical. The (fine) speed correction can be made by changing the position of the magnets which are located on either side of the copper (coloured) disc on the flywheel. The magnets influence the speed of the flywheel. By mechanical setting, the magnets can be placed with more or less surface above and below the copper (coloured) disc. A special construction that I've never seen before.

I adjusted the speed with the adjustment screws on the chassis. For the speed $3\frac{1}{4}$ (inch/s) the image of the tacho disc kept standing still. For the speed $7\frac{1}{2}$ (inch/s) I could not manage to get the image standing still it kept elapsing a little bit. I discovered that the adjusting lever for speed also adjust some switches on the circuit board. This concerns the speed independent adjustment of correction filters, the bias and the frequency response.

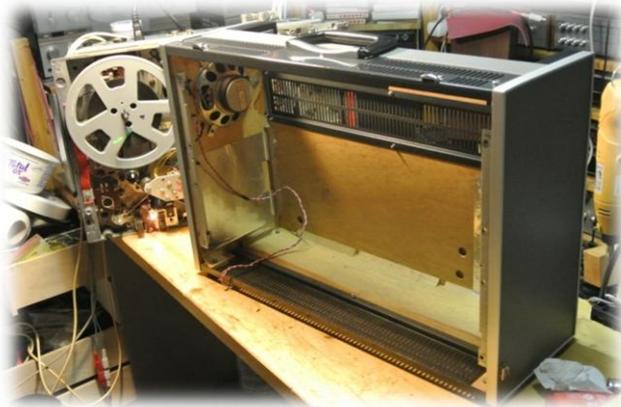
23-12-2014; cosmetic works

Unless the recorder was still looking good from the outside I had to do some work on the cabinet and cover. All the loose leatherette as well as a loose aluminium edge were glued again. The Plexiglas window in the cover was placed again with double sided tape. The handle was tightened again. Cabinet and cover were thoroughly cleaned and waxed. The Cabinet and cover are looking great again.

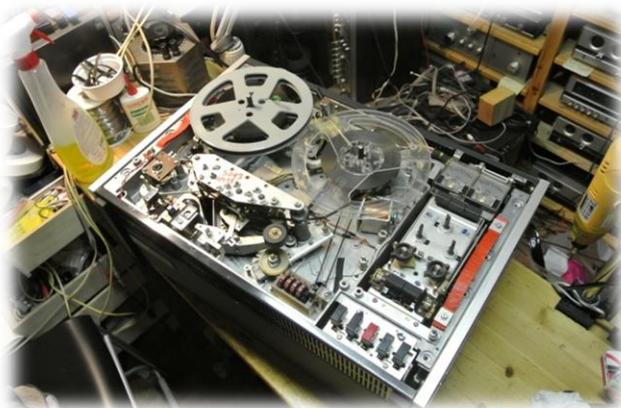
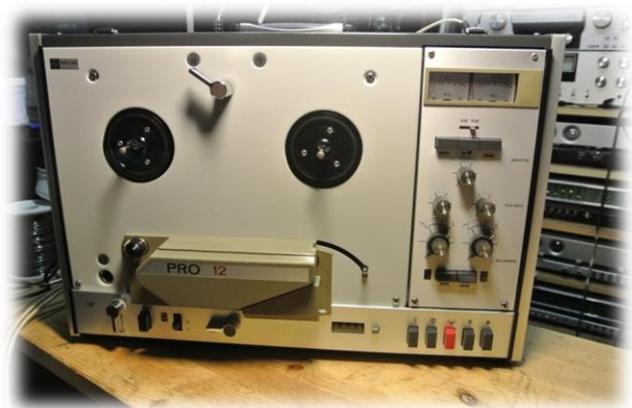
23-12-2014; reassembling recorder and cabin

Today I placed the recorder back in its cabin. Do not forget to connect the wires of the monitor speaker. I cleaned the front panels and mounted them again. Finally I cleaned the knobs with a tooth brush and put them back on their position. The job has been done, I love the results the PRO-12 is looking great and I am proud of it.

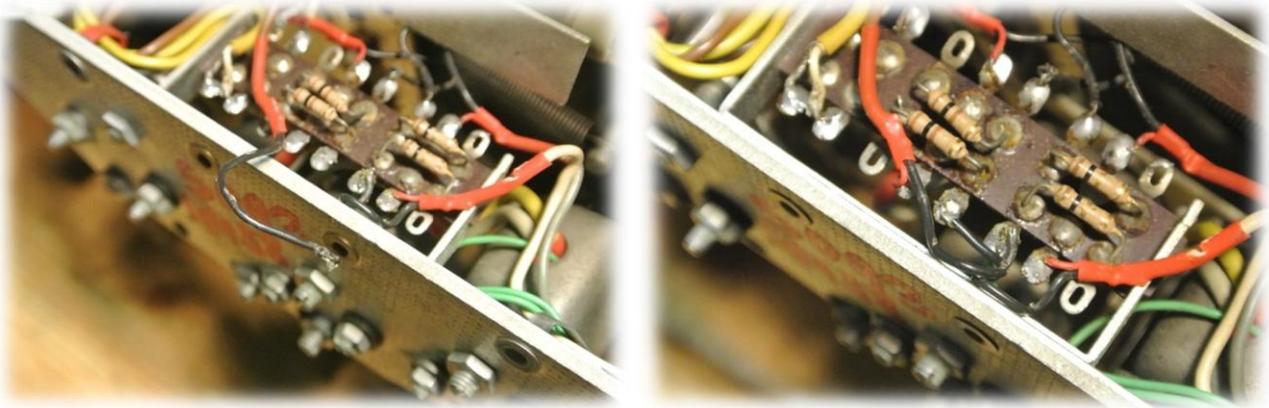
After the recorder neatly had been assembled completely I put another tape on it to have a final check of all the functions again. Unfortunately not everything was working anymore....., too bad. Recording on the left channel stopped functioning. There was signal input (before tape) but the signal was not recorded on tape (after tape). I will check this out later. First I am going to celebrate Christmas with my family.

The recorder was placed again on my Workbench today. The front panels were disassembled again. The problem was quickly found there was a loose connection behind the heads. I soldered the wire back on and tested the recorder again. The signal of the left channel had returned on the tape....., I am happy. The front panels were mounted again and I made another test tape with music by Tiësto. I'm listening to that recording right now with my Philips N6330 headphones. It sounds good over the entire frequency range, bright, all details are displayed correctly and a good stereo image. This is a really good recorder. I'm happy with it and still have a lot of fun to go with this PRO12. On to the next project.
